Ninth Quarterly Report

Date of Report: *September 14, 2010*

Project Title: Effect of Concentration and Temperature of Ethanol in Fuel Blends on Microbial and Stress Corrosion Cracking of High-Strength Steels

Prepared by: Colorado School of Mines and National Institute of Standards and Technology

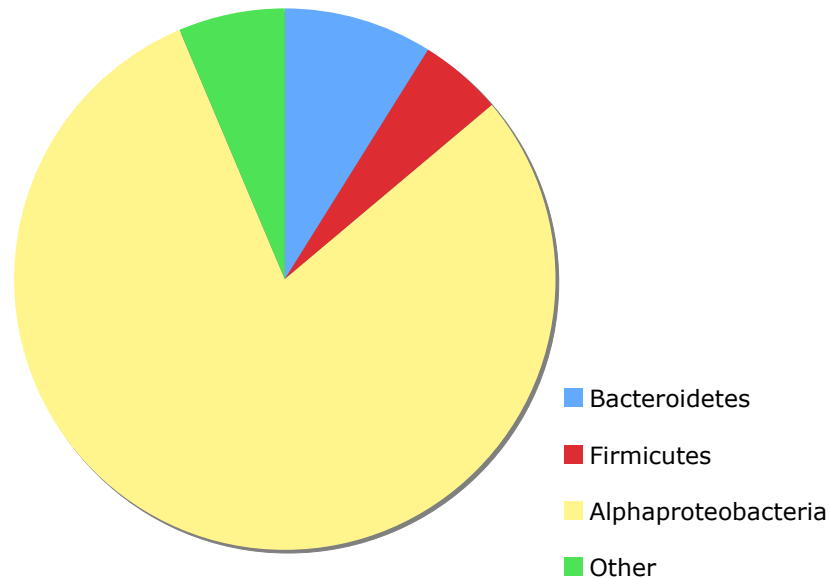
Figure 2 Microbial community composition of tank bottoms sample collected from fuel-grade ethanol (FGE) underground storage tanks (UST) containing FGE and water. *Alphaproteobacteria* representatives are comprised of acetic-acid-producing bacteria.

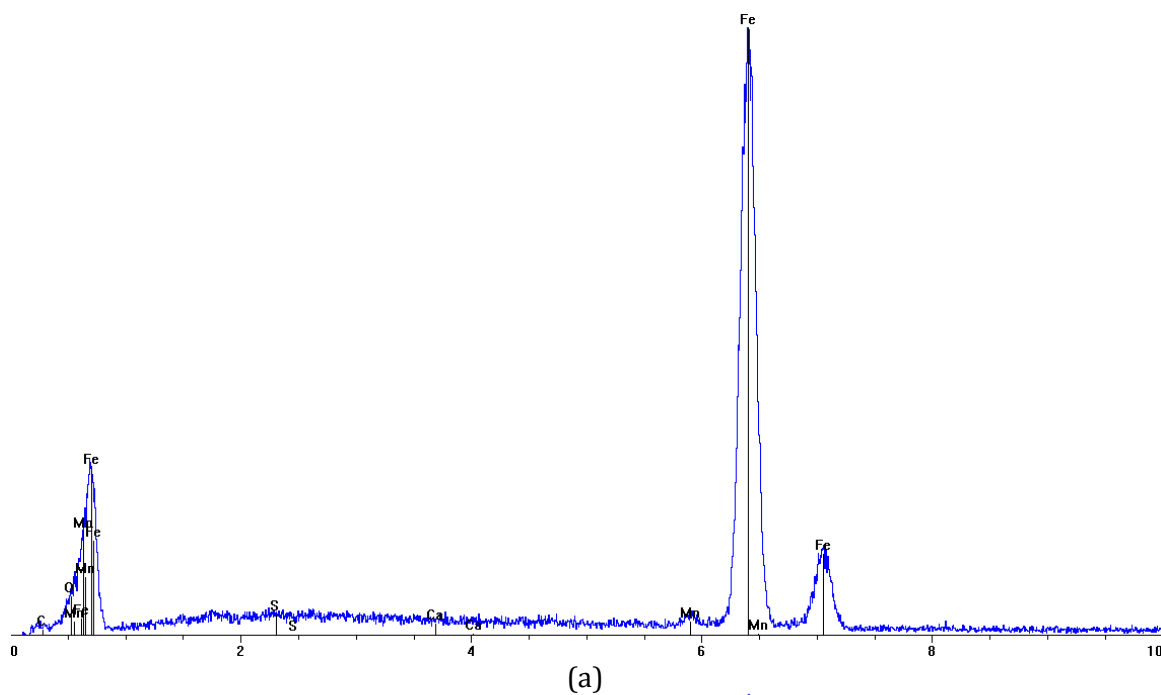
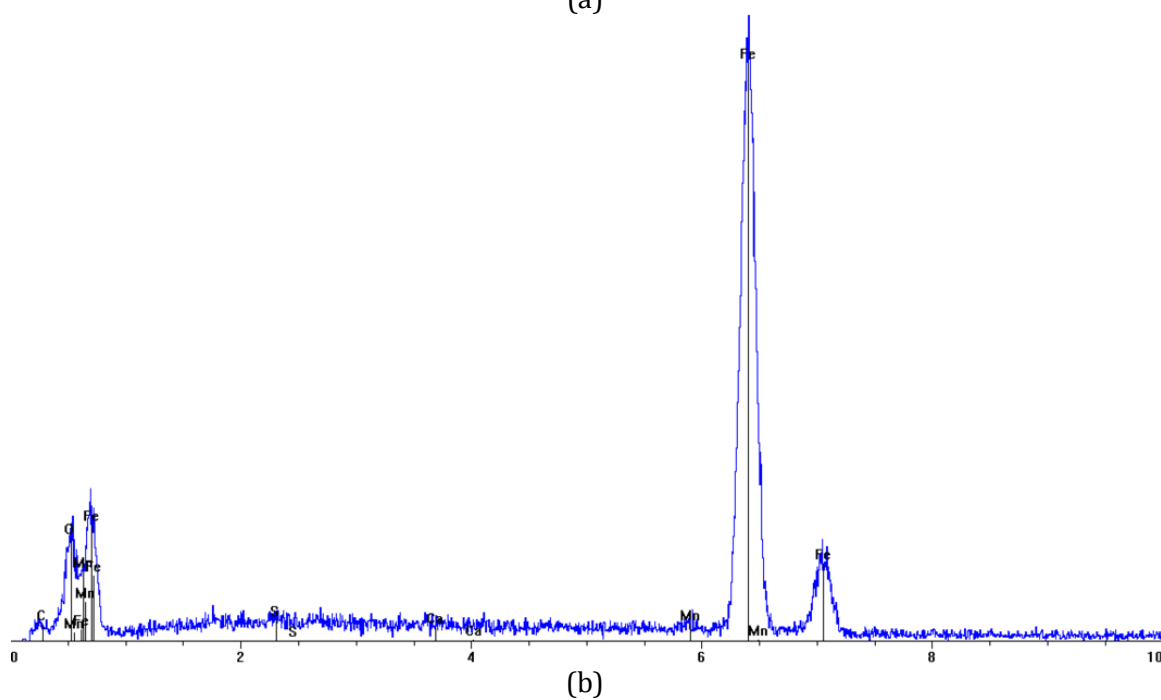
EDS spot analysis of locations 1 and 5 are shown in Figure 7. The presence of large iron peaks along with the absence of significant signals of any other elements indicates that the base of the pit, where it is not covered by scale, is most likely predominately composed of elemental iron.

Figure 7 Energy dispersive X-ray spectroscopy (EDS) spot analysis at 20 kV of (a) location “1” showing predominantly iron peaks indicating metallic iron (b) location “2” showing iron and oxygen peaks indicating iron oxide

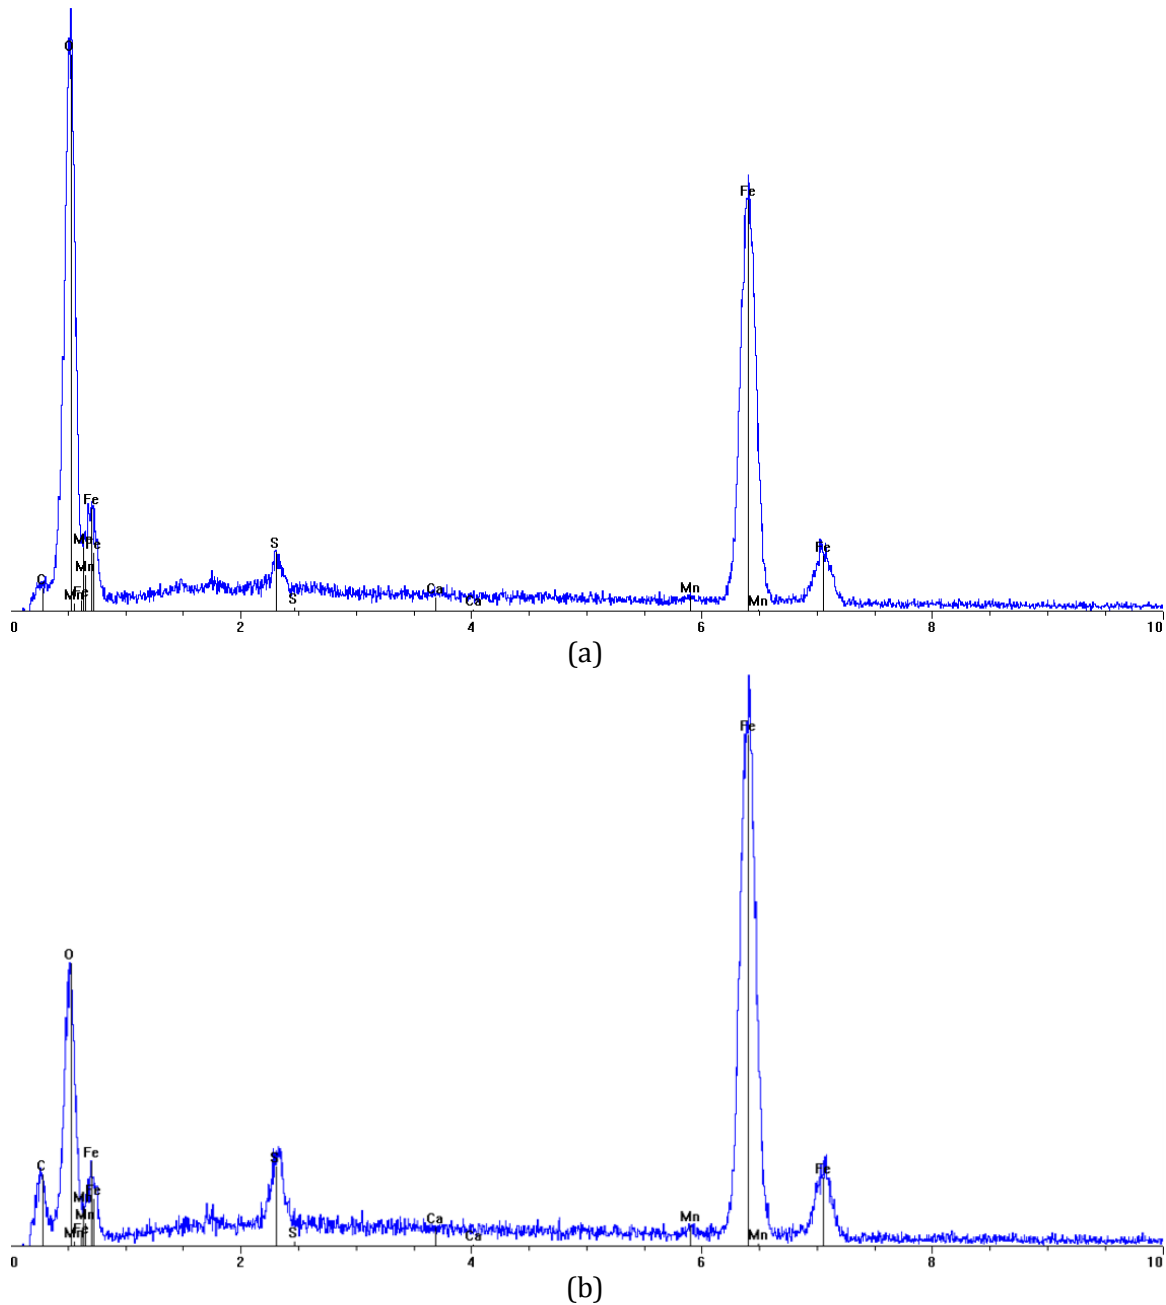
Figure 8a depicts an EDS spot analysis performed on area 3 in a region of the pit still covered in scale. Strong iron and oxygen signals, along with significant sulphur and carbon peaks indicate that the scale is largely composed of iron oxide but also contains sulphur and carbon. Figure 8b

displays EDS spot analysis of location 4. Strong iron peaks and sizable oxygen peaks are present. Larger carbon and sulphur peaks can also be observed. The presence of sulphur and carbon in the scale of a pit can indicate MIC.

Figure 8 Energy dispersive X-ray spectroscopy (EDS) spot analysis at 20 kV of (a) location "3" showing iron and oxygen peaks indicating iron oxide with some amount of sulfur species (b) location "4" depicting large iron and oxygen peaks as well as smaller carbon and sulphur peaks indicating iron oxide with some amount of both sulfur and carbon species

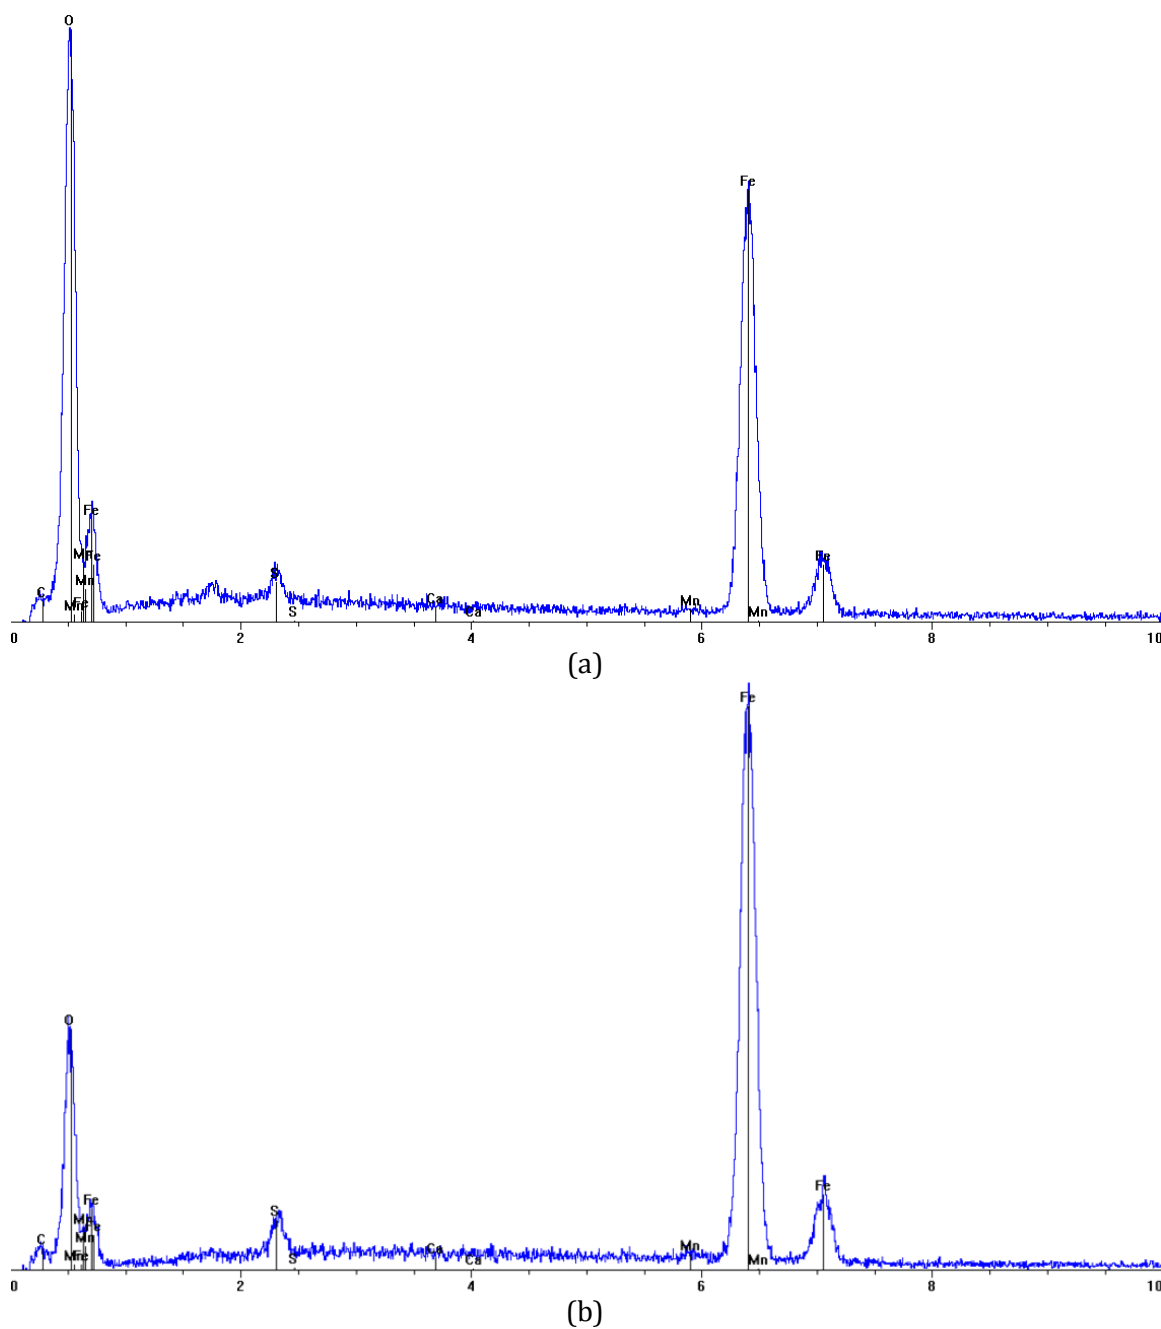
Locations 2 and 6 comprise areas of the pit still covered by scale. Location 2 represents one of the largest regions of an intact scale deposit. Figure 9a shows very large iron and oxygen signals corresponding with this area indicating that the scale most likely has significant concentrations of iron oxide. A small sulphur peak is also visible indicating the possible presence of iron sulphide or other sulphur species. Location 6 also represents an area covered in scale yet very close to location 5, which is free of scale. The EDS spot analysis of this location yields a strong iron signal and a significant oxygen signal. A somewhat smaller sulphur peak is also observed. This most likely indicates metallic iron, iron oxide, and some sulphur compound, possibly an iron sulphide.

Figure 9 Energy dispersive X-ray spectroscopy (EDS) spot analysis at 20 kV of (a) location 5 showing predominantly iron peaks indicating metallic iron (b) location 6 showing large iron and oxygen peaks and a smaller sulphur peak indicating the presence of iron oxide as well as some sulphur

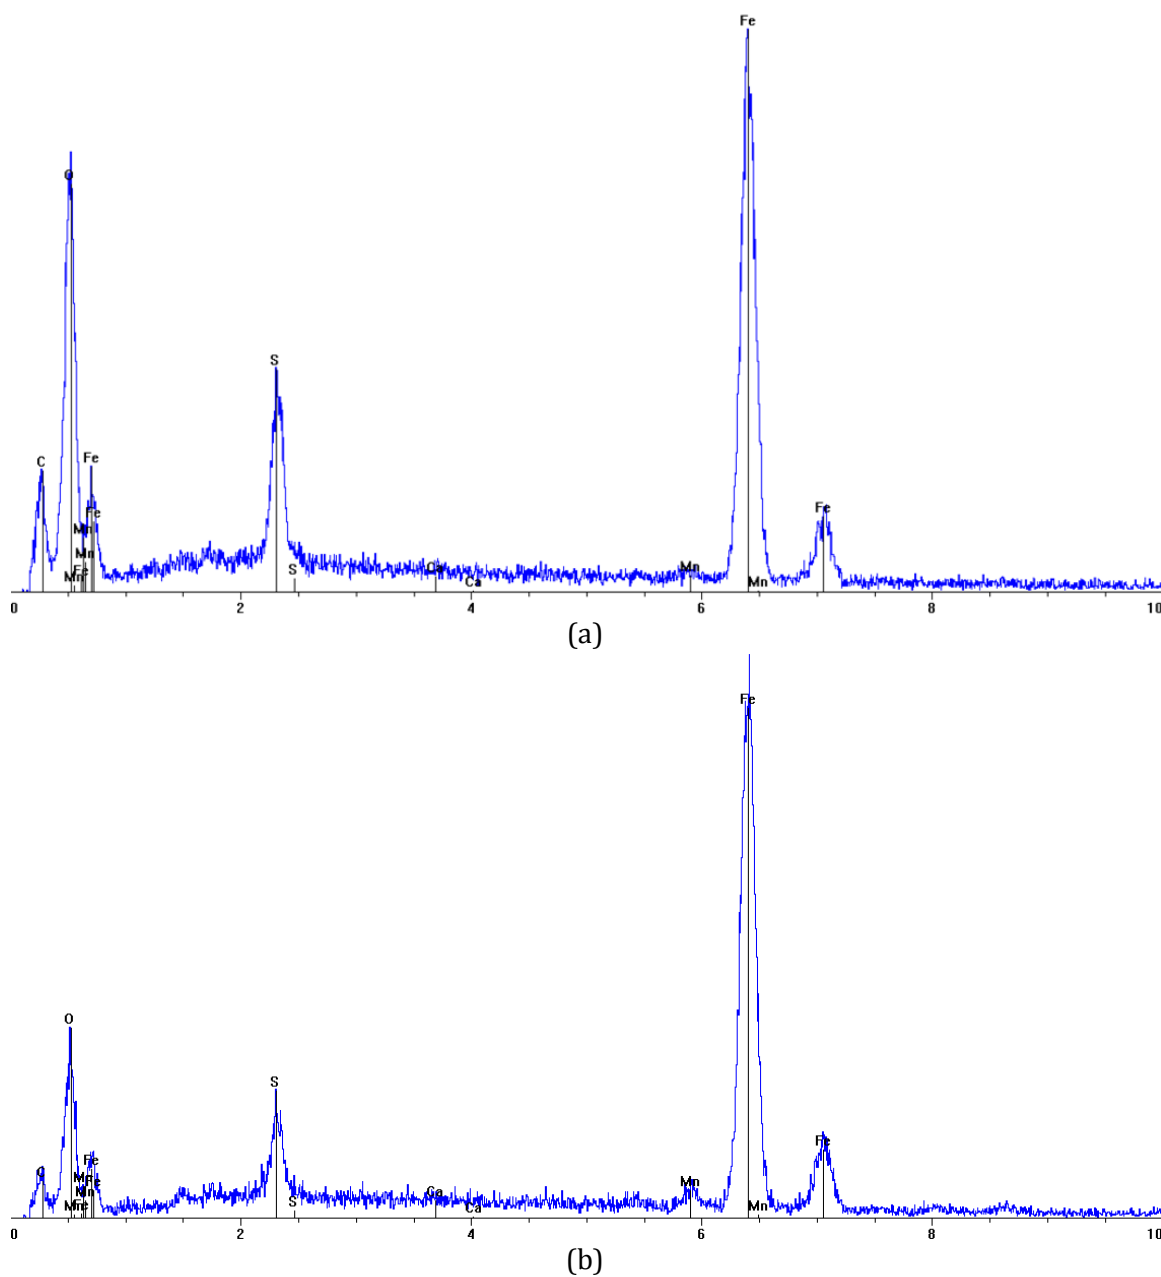
Areas 7 and 8 are located on the edge of the intact scale in the central region of the pit. These areas were of particular interest. Along with the expected presence of iron and oxygen, relatively large carbon and sulphur signals were also commonly observed. These signals can be seen in especially in Figure 10a and also in Figure 10b. A small but noticeable manganese signal should also be noted in Figure 10b. Manganese oxide is associated with manganese oxidizing bacteria and known to be present in zones of MIC (B. J. Little 2006).

Figure 10 Energy dispersive X-ray spectroscopy (EDS) spot analysis at 20 kV of (a) location 7 showing large iron, oxygen, and sulphur peaks as well as a carbon peak indicating iron oxide, a sulphur species, and some form of carbon (b) location 8 showing large iron as well as smaller oxygen, sulphur, and carbon peaks indicating metallic iron as well as some oxide, sulphur, and carbon and a smaller sulphur peak indicating the presence of iron oxide as well as some sulphur

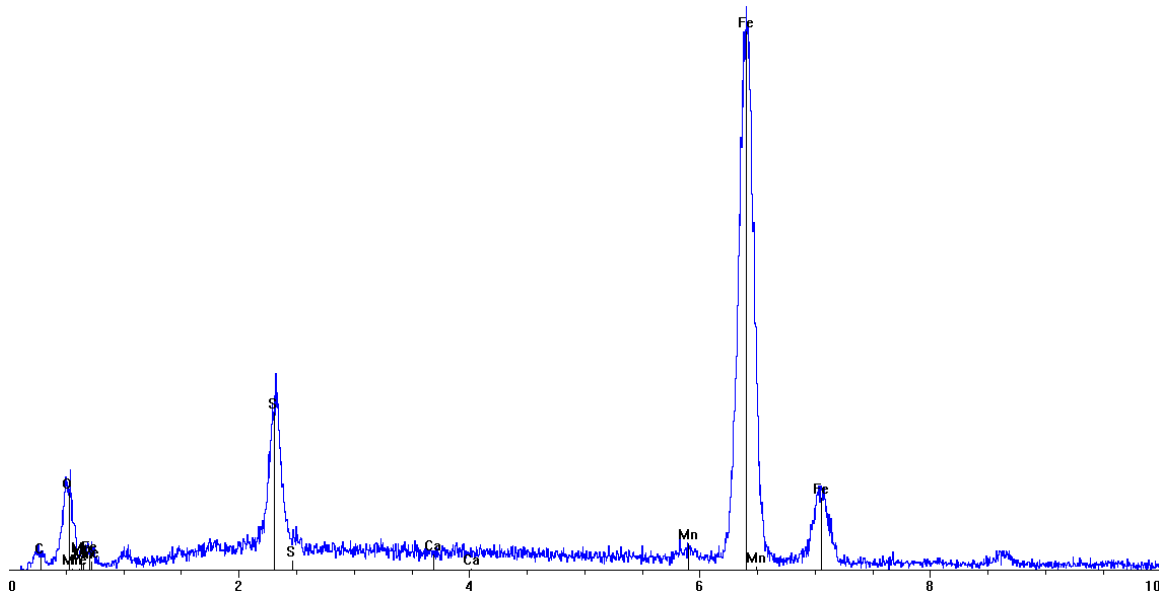
Area 9 is also located on the edge of the intact scale in the central region of the pit. Again, in addition to a strong iron signal, a large sulphur peak is present.

Figure 11 Energy dispersive X-ray spectroscopy (EDS) spot analysis at 20 kV of location 9 showing large iron and sulphur peaks as well as a small oxygen peak indicating the presence of iron as well as some concentrations of oxygen and sulphur species

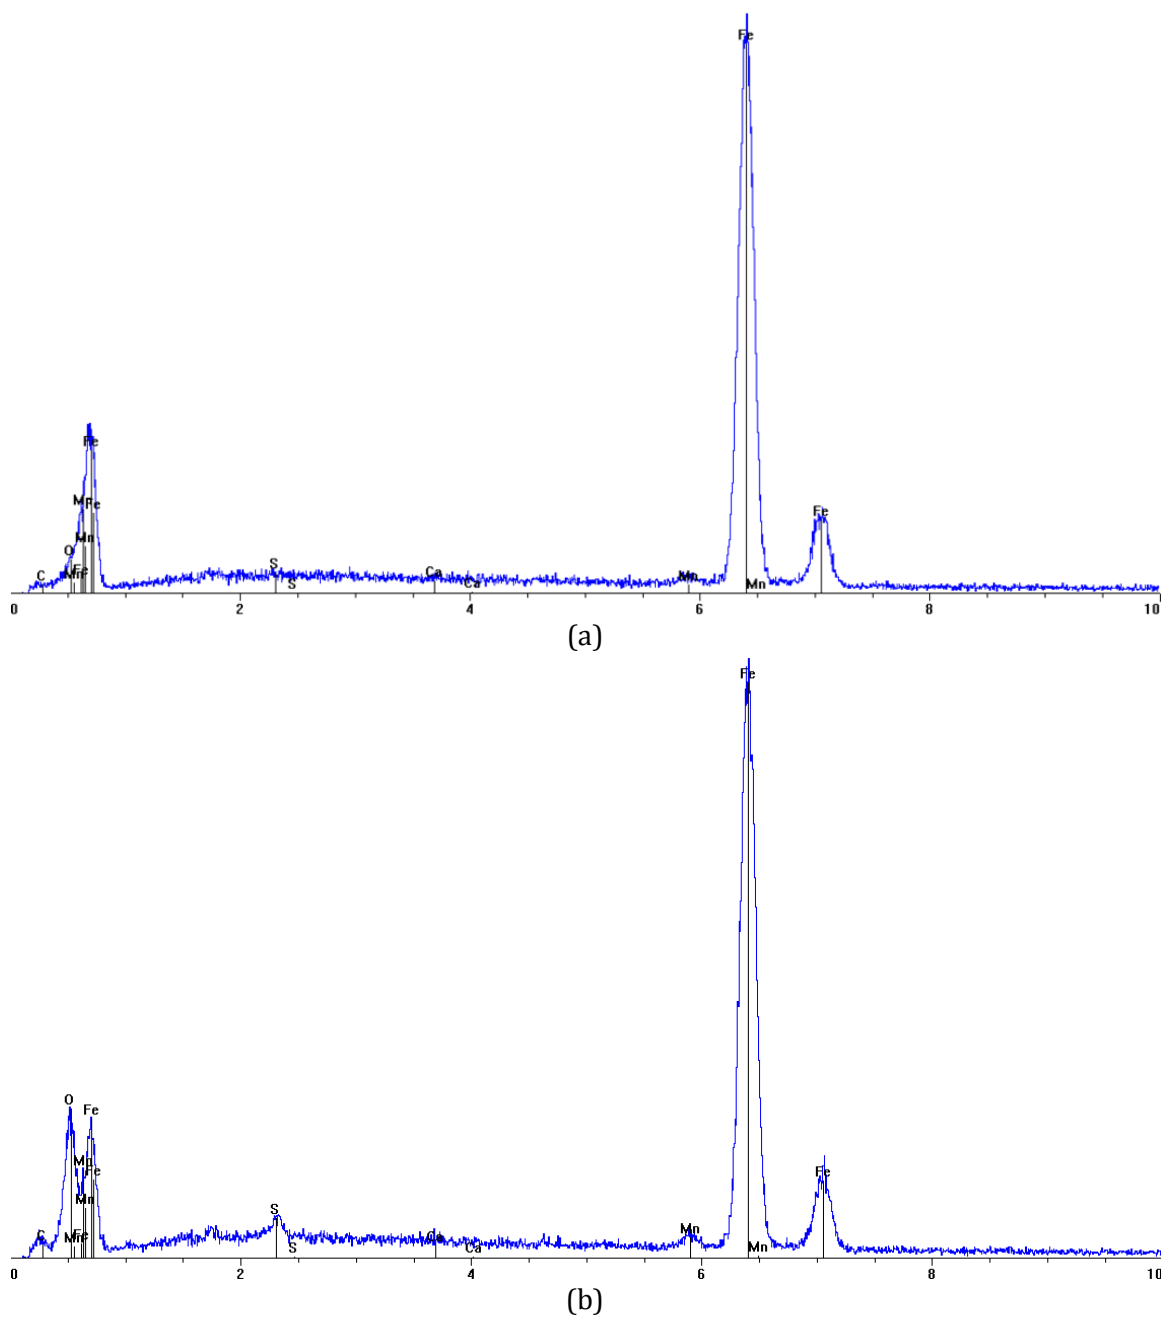
Locations O and N represent the right-hand side and upper right hand corner of Figure 13 showing the uncovered base of the pit. EDS spectra of these locations shown in Figure 14 demonstrate an EDS spectra characteristic of metallic iron.

Figure 14 Energy dispersive X-ray spectroscopy (EDS) spot analysis at 20 kV depicting strong iron peaks and smaller oxygen, sulphur and manganese peaks indicating predominately metallic iron with smaller amounts of oxides, sulphur, and manganese species of an API X70 steel coupon at locations in area “7” (Figure 13) (a) “O” and (b) “N”

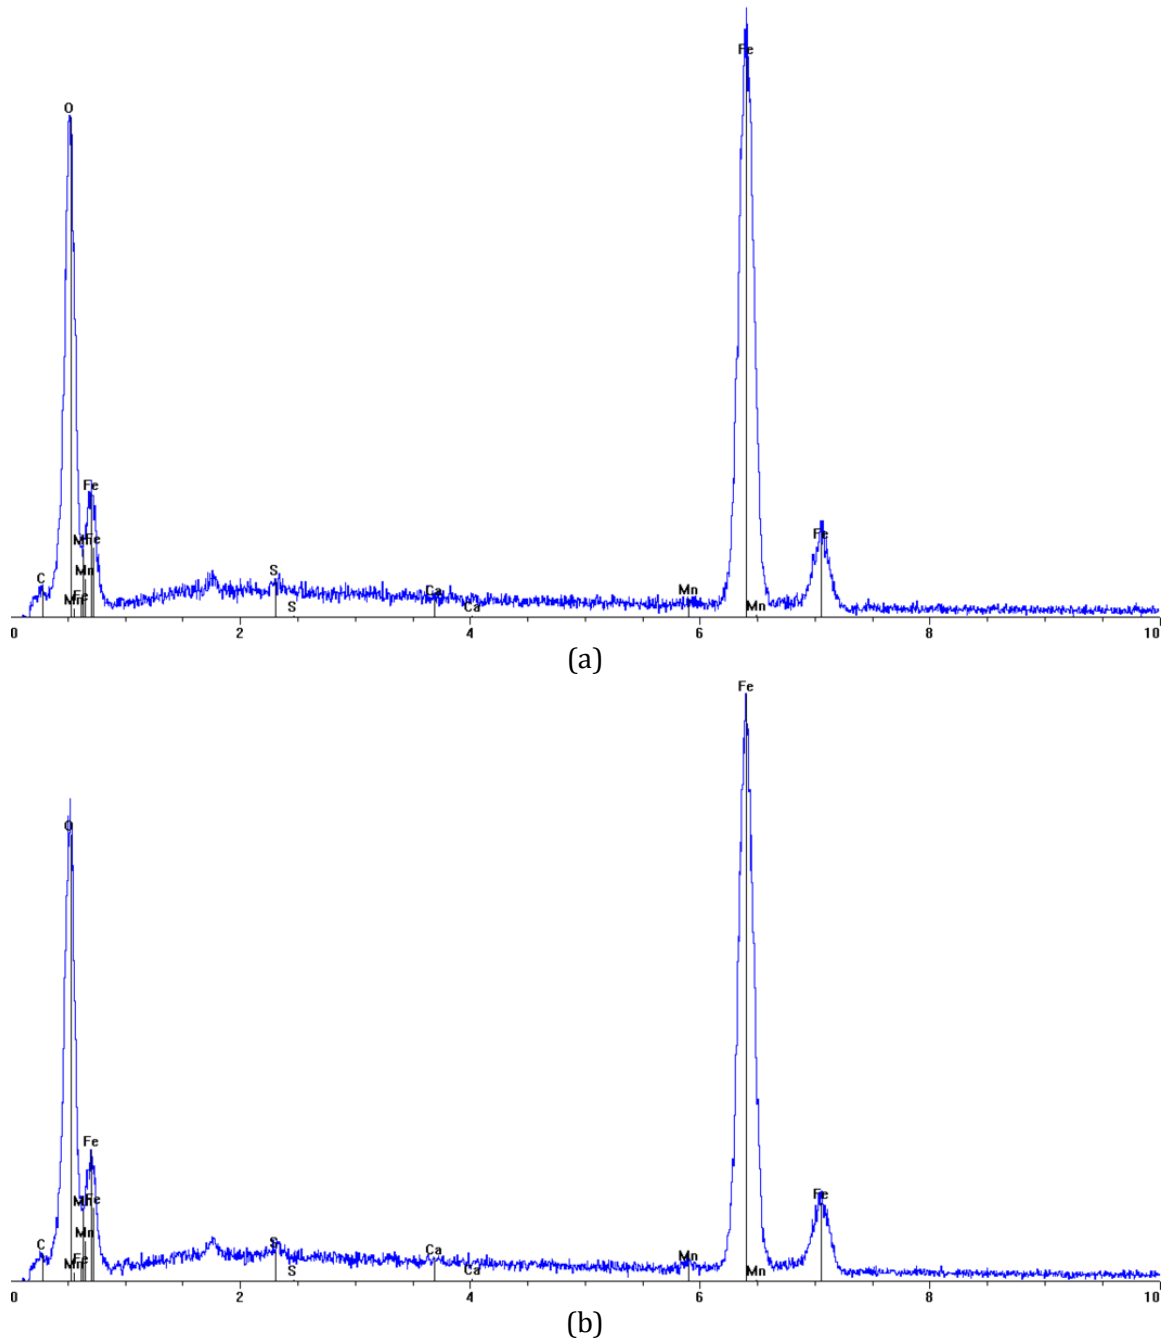
Locations C and G in the lower left-hand corner of Figure 13 represent a localized area covered with intact scale. The EDS spot analysis of these areas [Figure 15] indicates the presence of iron oxide.

Figure 15 Energy dispersive X-ray spectroscopy (EDS) spot analysis at 20 kV depicting strong iron and oxygen peaks as well as small carbon, sulphur, and manganese peaks indicating predominately iron oxide along with the presence of carbon, sulphur, and manganese species at locations in area “7” (Figure 13) (a) “C” and (b) “G”

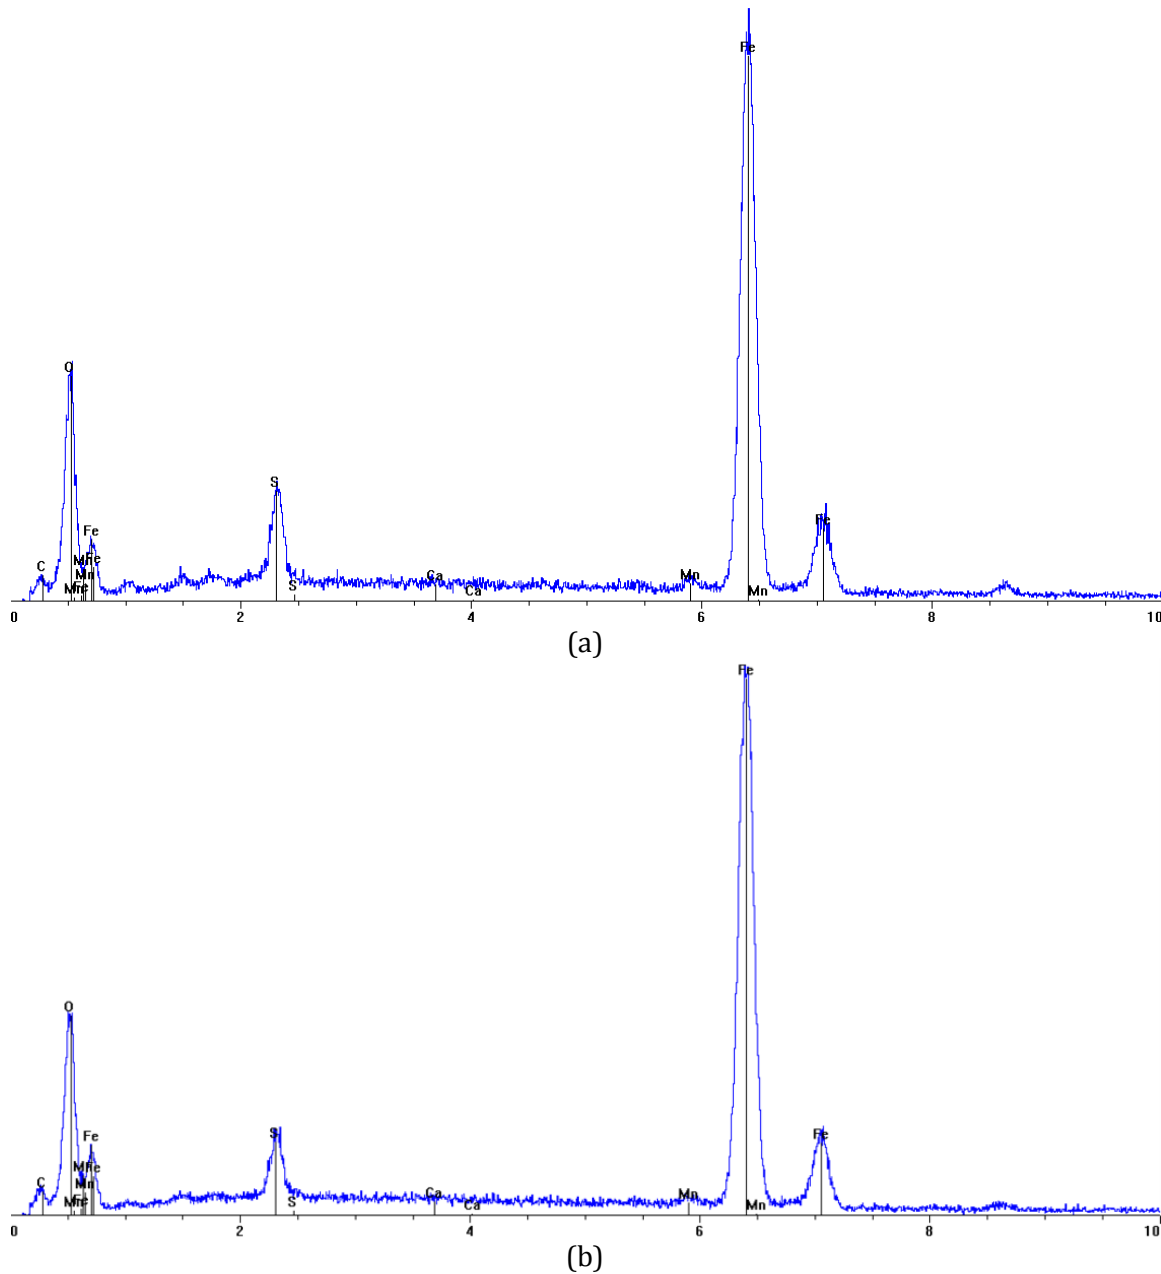
Locations H and K were selected to represent the intermediate area between the right side of the micrograph depicting the exposed surface of the pit and the region identified by D, A, and R showing a possibly organic morphology. The spectra in Figure 16 showing iron, oxygen, and sulphur indicate that this region may represent a transition region from metallic iron to area of suspected microbial activity.

Figure 16 Energy dispersive X-ray spectroscopy (EDS) spot analysis at 20 kV depicting strong iron and oxygen peaks as well as a moderately sized sulphur peak and smaller carbon, sulphur, and manganese peaks indicating iron and iron oxide along with the presence of carbon, sulphur, and manganese species at locations in area “7” (Figure 13) (a) “B” and (b) “K”

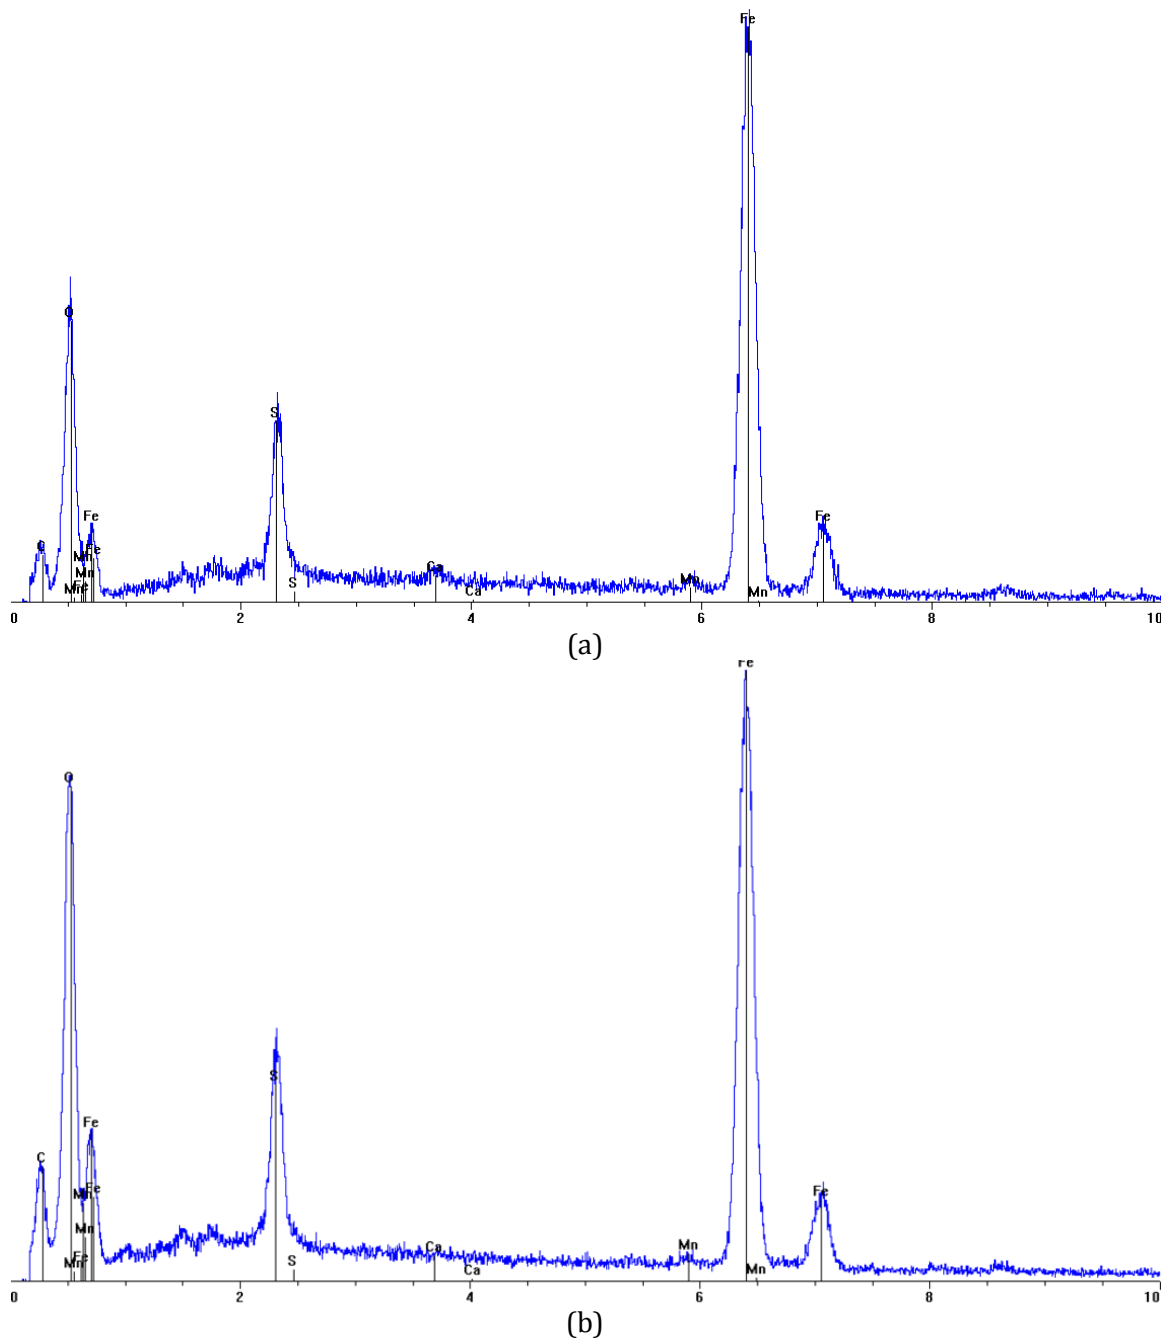
Locations D and I are comprised of a unique morphology that may have been microbiologically generated. The EDS spot analysis of this area shown in Figure 17 supports the possibility of microbial activity as it contains strong sulphur and carbon signals when compared to other locations on Figure 13.

Figure 17 Energy dispersive X-ray spectroscopy (EDS) spot analysis at 20 kV depicting strong iron and oxygen peaks as well as a moderately sized sulphur and carbon peaks and slight calcium and manganese peaks indicating iron and iron oxide along with the presence of sizable quantities of carbon, sulphur, and manganese species at locations in area “7” (Figure 13) (a) “A” and (b) “T”

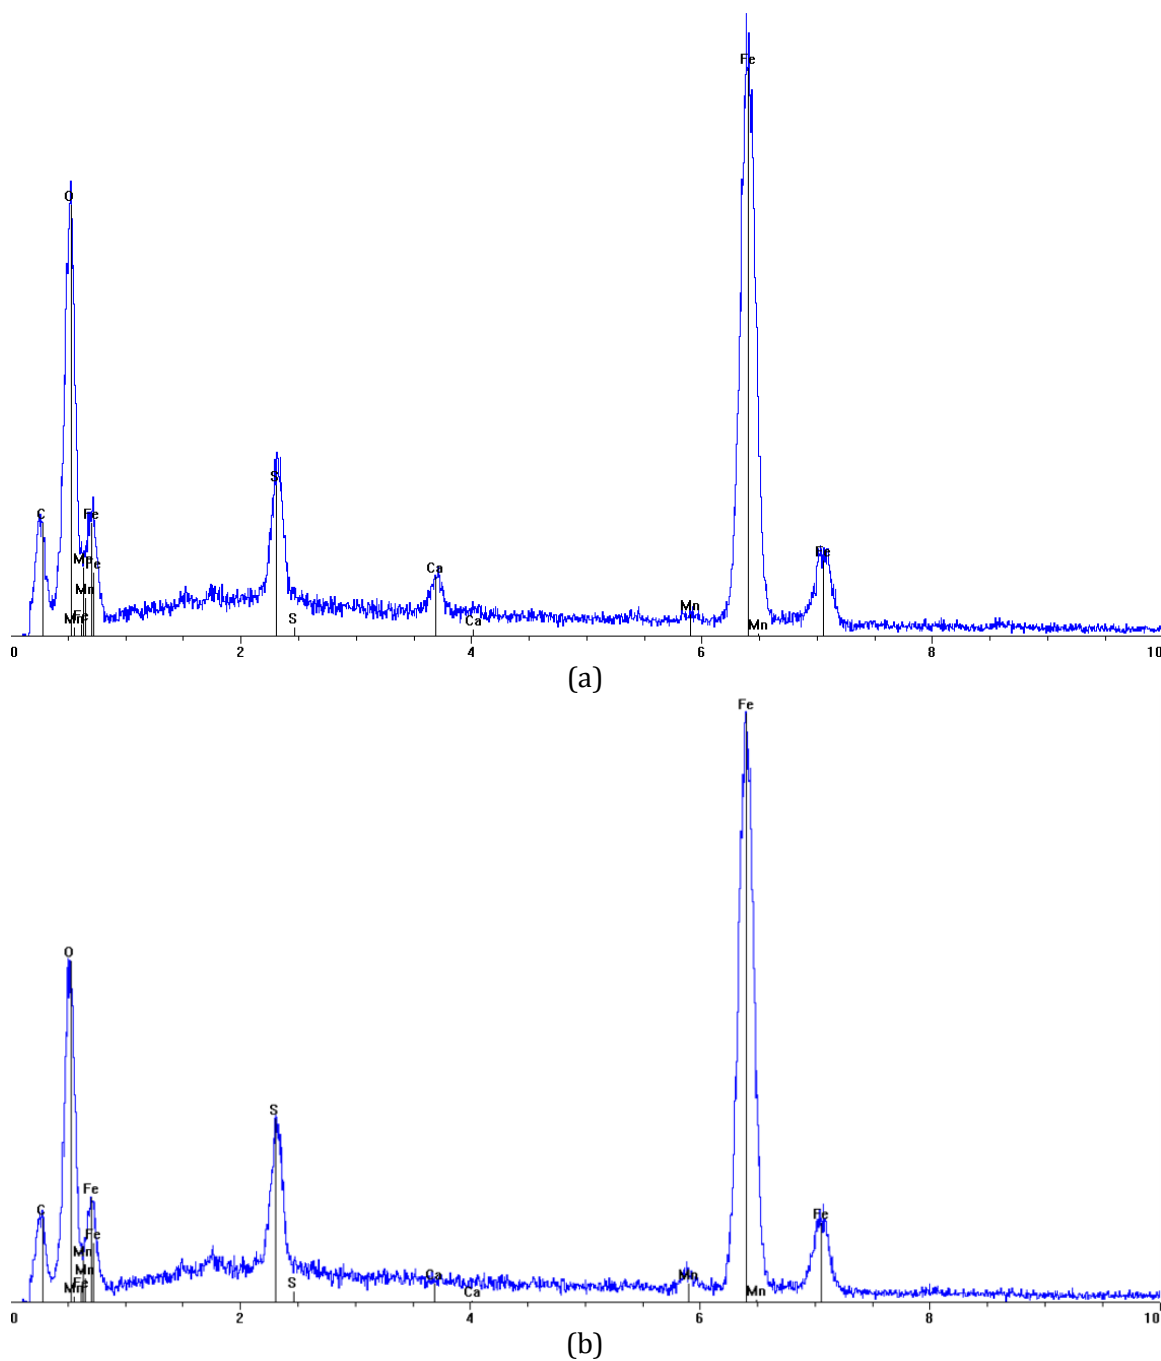
Locations E and F, adjacent to the suspected biofilm were also of particular interest. As shown in Figure 18 these deposit were rich in not only carbon and sulphur, but in one case [Figure 18] calcium. Calcium deposits are known to occur due to pH gradients caused by the action of microbial activities in biofilms near metallic surfaces (Videla 1992).

Figure 18 Energy dispersive X-ray spectroscopy (EDS) spot analysis at 20 kV depicting strong iron and oxygen peaks as well as a moderately sized sulphur, carbon, and calcium (a) peaks and slight manganese peaks indicating iron and iron oxide along with the presence of sizable quantities of carbon, sulphur, calcium and some manganese species at locations in area “7” (Figure 13) (a) “E” and (b) “F”

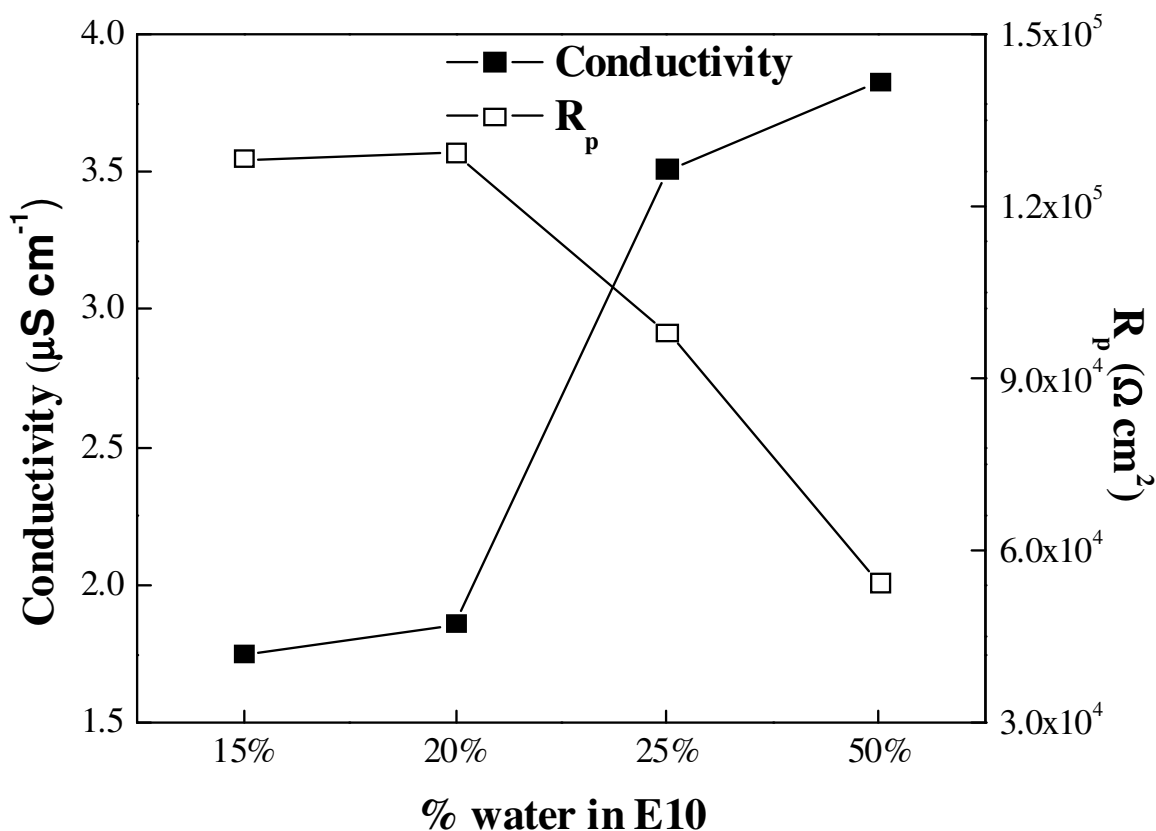
Figure 21 shows the polarization resistance of ASTM A36 carbon steel in water-ethanol phase and the conductivity of water-ethanol phase upon water addition to E10. It is evident from the figure that the conductivity of the aqueous phase increases with increase in water concentration to E10. The maximum change in conductivity takes place in the range 20-25 %. Polarization resistance of ASTM A36 carbon steel decreases with increase in water concentration to E10, correlating with the order of conductivity. The increase in conductivity accords with the observed increase in corrosion rate for the steel specimens.

Figure 21 Polarization resistance and conductivity measurements of ASTM A36 carbon steel in the water-ethanol phase of E10 and water mixtures
